Carlton Plain Stage 1 Triennial Weed Mapping – Field Notes and supporting images
1 August 2023

Tracked on Cambridge Gulf DS52-14 map in Avenza (on iPad)
Route travelled East to West to House Roof Hill to East.
Debra Pearce and Wayne Paul (driving)

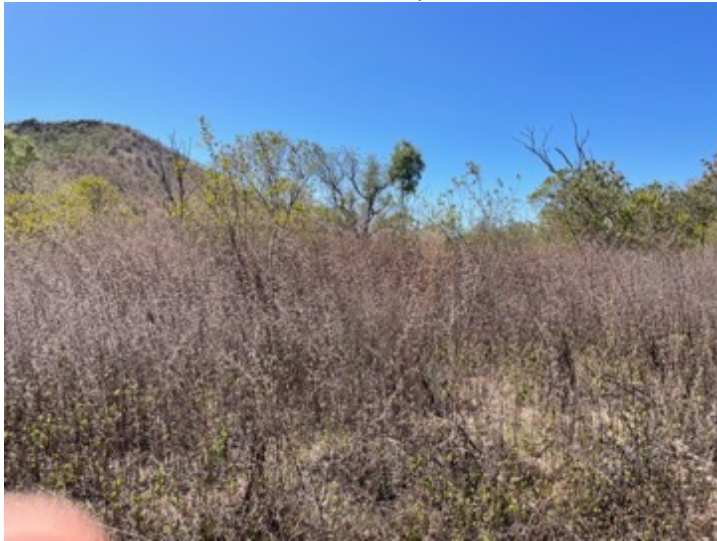
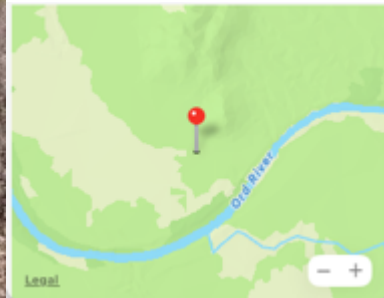
Hiptis -15.563500 128.571801

50-80% weeds. Rosewood, Calotropis

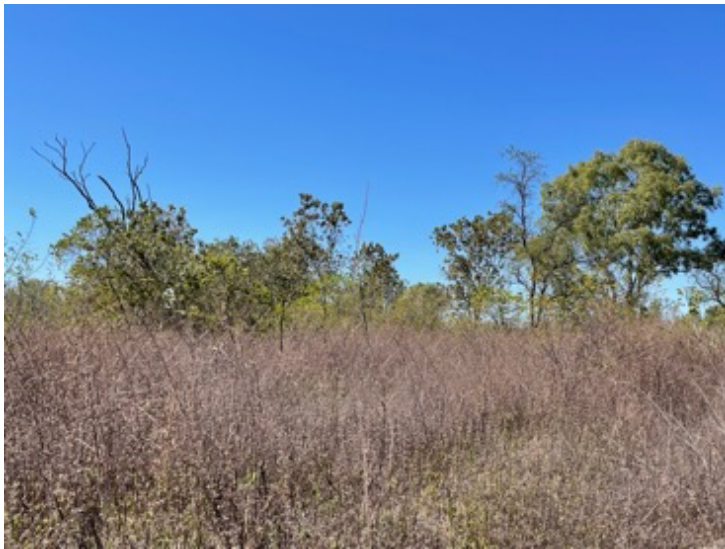
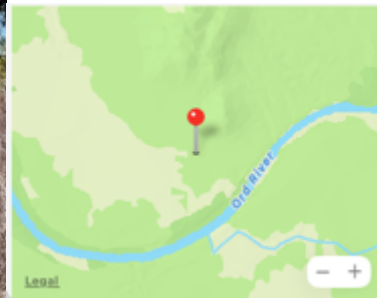
East side: bad Calotropis. 50-80% weeds

-15.564129 128.572657

Rosewood, Hiptis

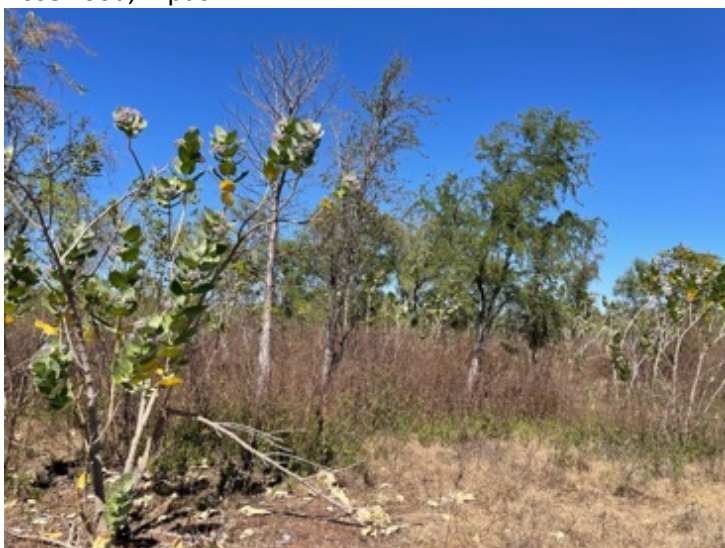
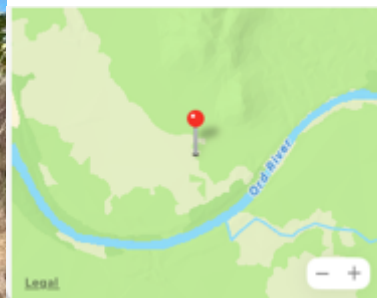
Y17A bore
50-80% weeds
-15.154529 128.572657
Calotropis, Hiptis, rosewood
Bore 11.6m deep – dry
Photos emailed

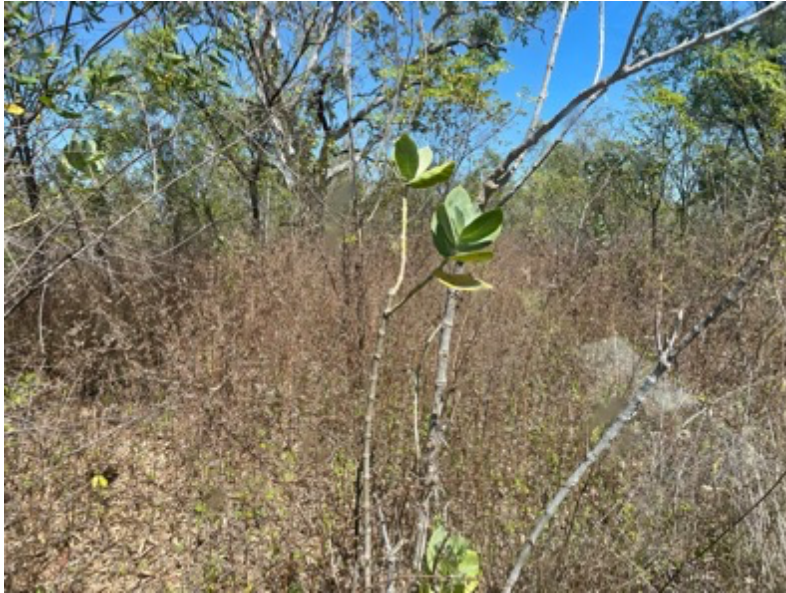
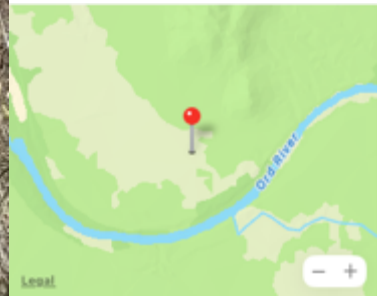
-15.56480 128.572969
Weeds >80%
On the 'D' on map after squiggle on track log

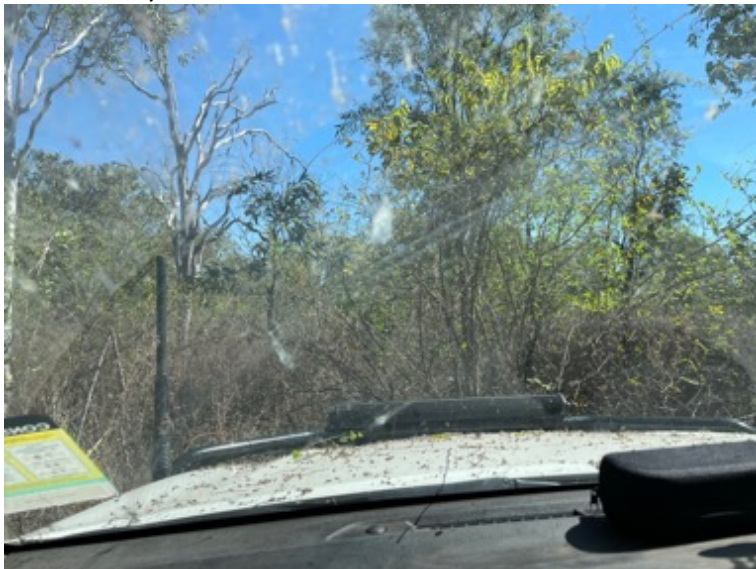
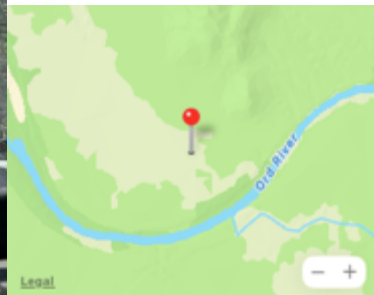
Y17 Bore
GWL 11420 TOC
-15.567767 128.565896
Photos sent
Bore depth 13m, water at 11420
No native grasses evident
Under storey 100% weeds

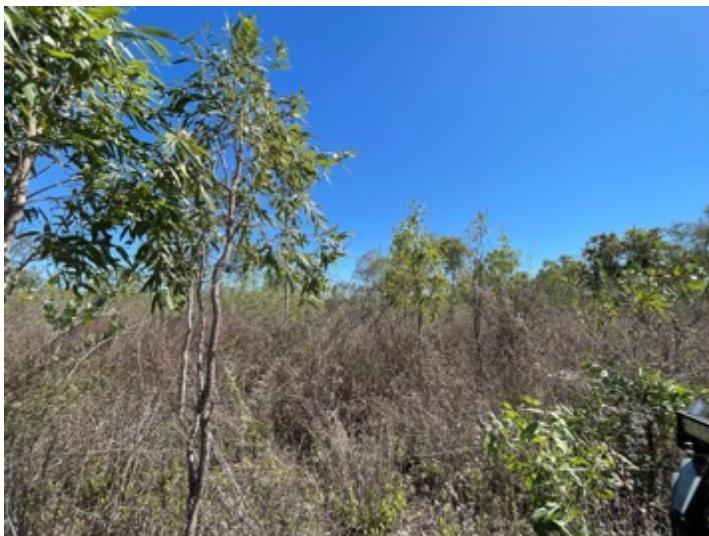
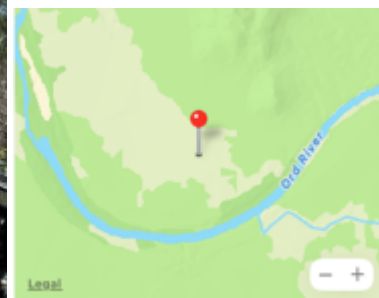
Track east side down to river
80% weeds
Neems as well as previous weeds
-15.573327 128.571529
Hiptis really thick. No cattle

River side of fence on south boundary: really bad neems, Hiptis, rosewood, Calotropis
-15.575791 128.560154

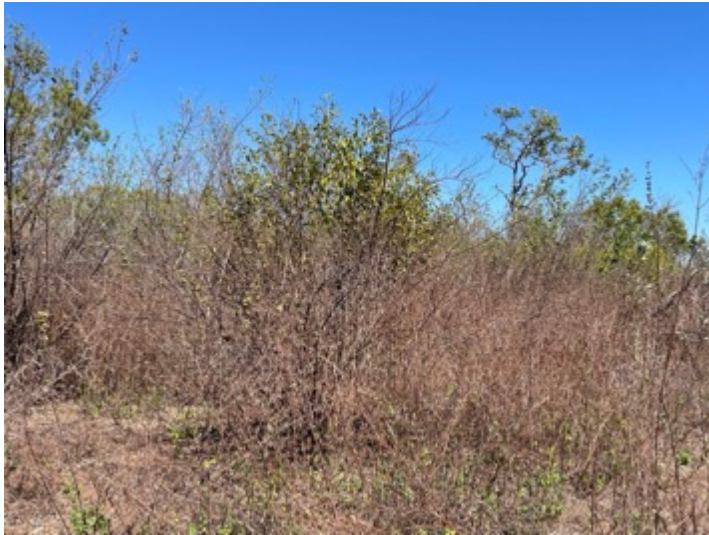
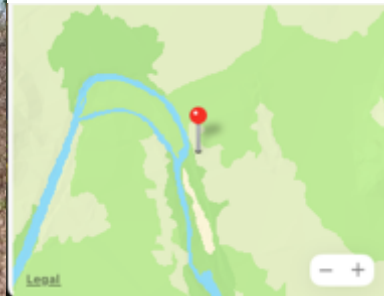
Really bad weeds both sides of track as heading back north >90% weeds. Occasional eucalypts.
Under storey 100% weeds. -15.567127 128.546445.

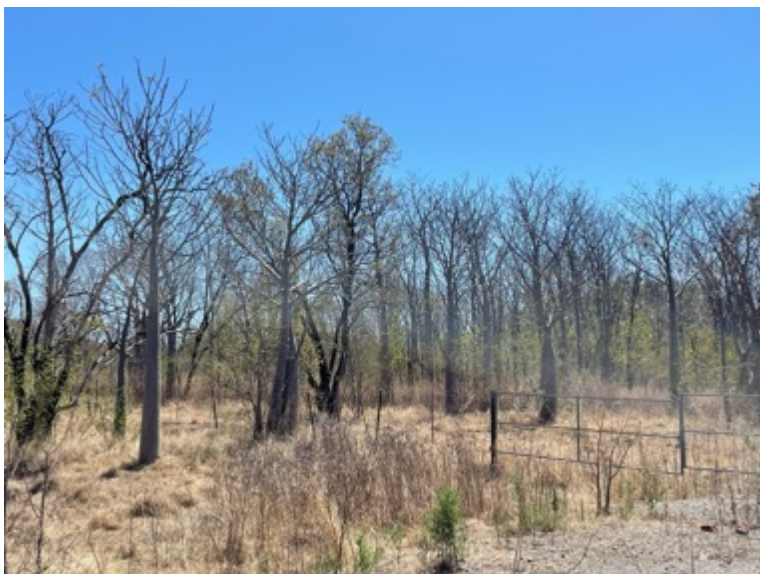
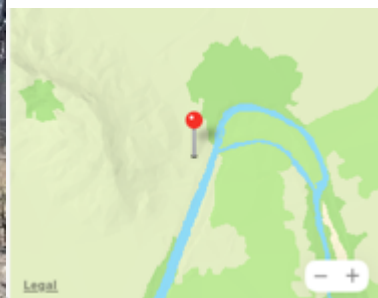
Bore 16A: 15070 GWL TOC (C = 90cm)
 Weeds >90%
 All understory = Hiptis, rosewood, Calotropis, neem
 -15.547696 128.541239
 No cattle evident

North-west of Macka's Barra Camp
 Weeds 2-20%
 Boabs 80%

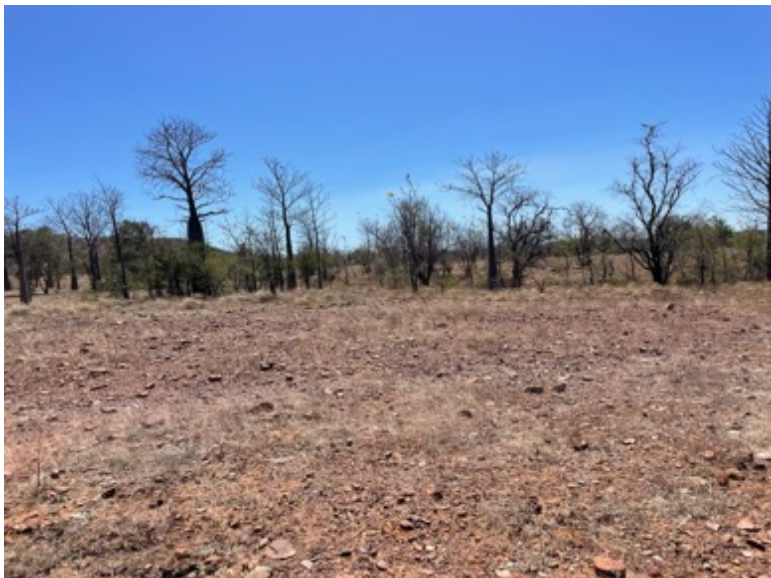
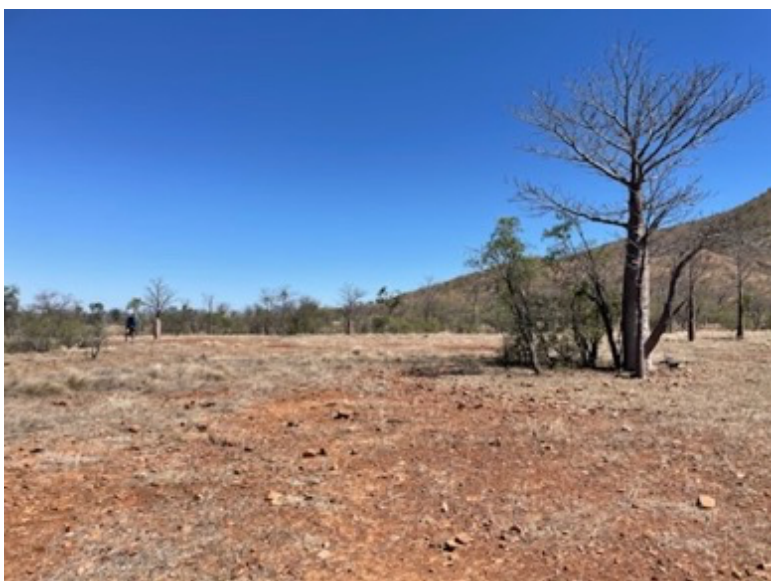
Gate entry 2-20% weeds -15.543499 128.519321

Near river <2% weeds; gravel and boabs, -15.550330 128.518274

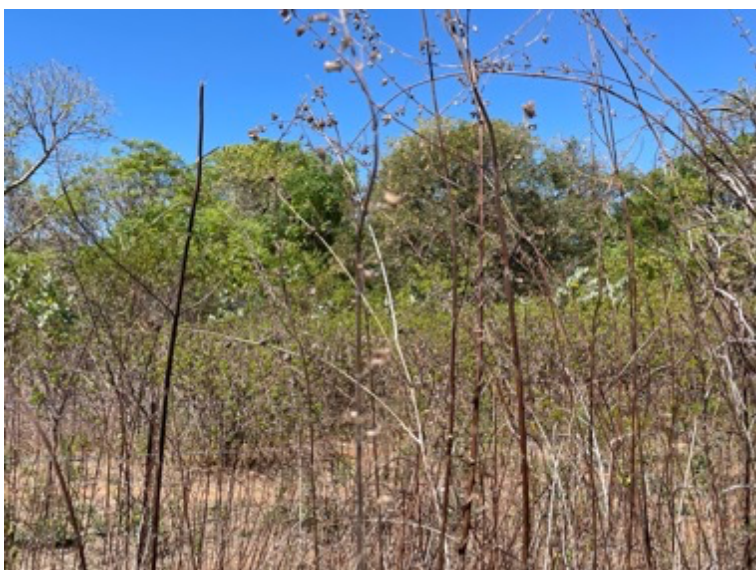
-15.557873 128.513840 Weeds 50-80%

Neems, Calotropis, river side of fence

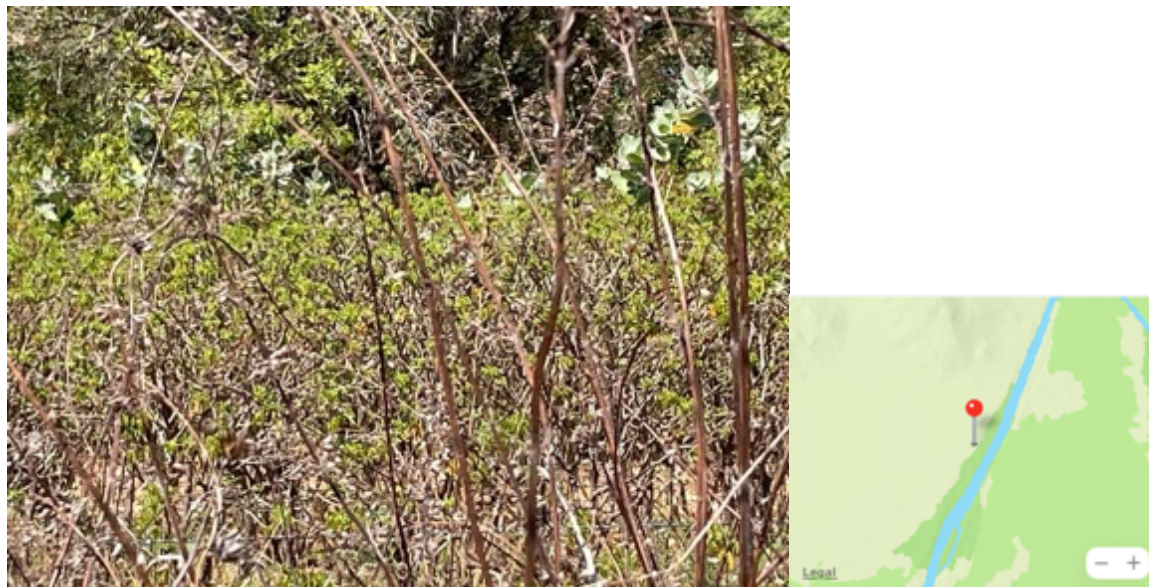
>80% weeds both sides of fence -15.561428 128.512447
Neems, Calotropis, Hiptis, Rosewood

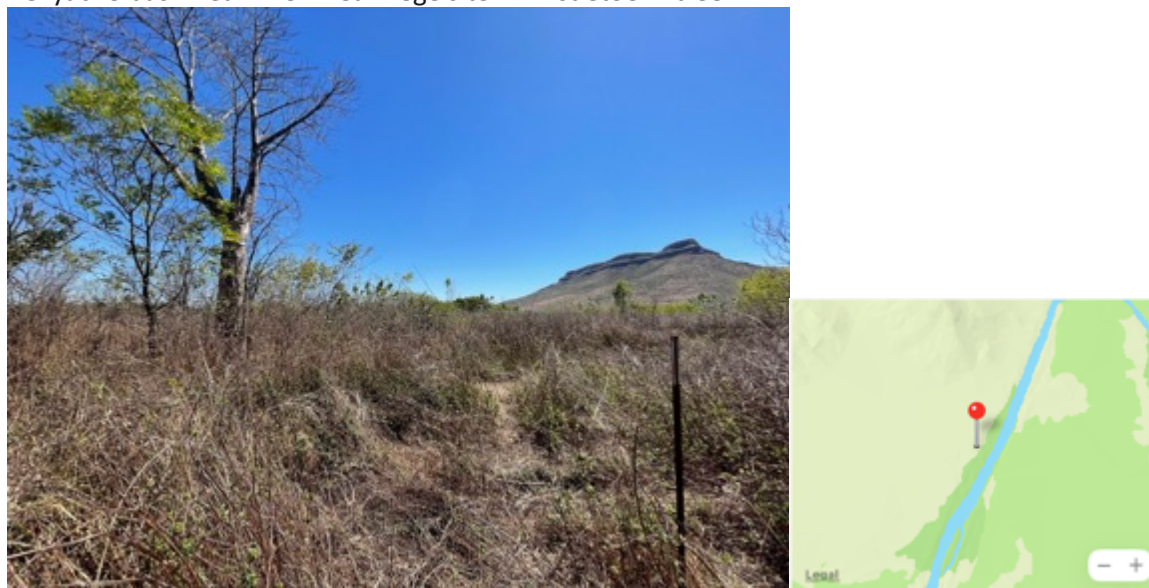
>80% weeds continues on drive south on lowest part on eastern side

-15.564637 128.511064

Bellyache bush near river. Near Vege site 1. Mistletoe in tree

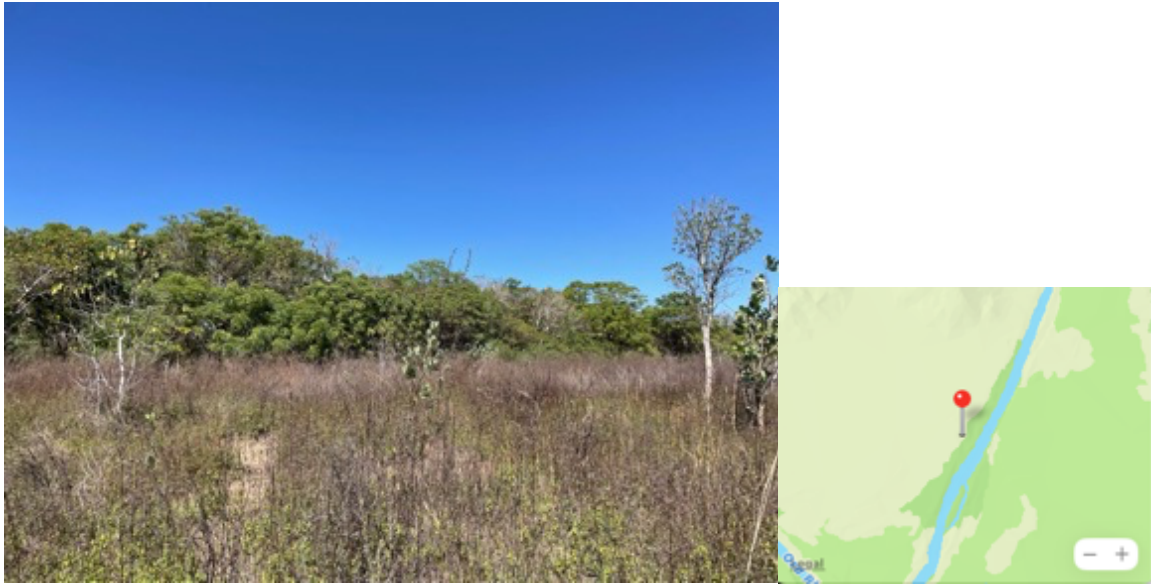
80% weeds between Vege site 1 and vege site 2
Rain tree along river.
Bellyache bush.

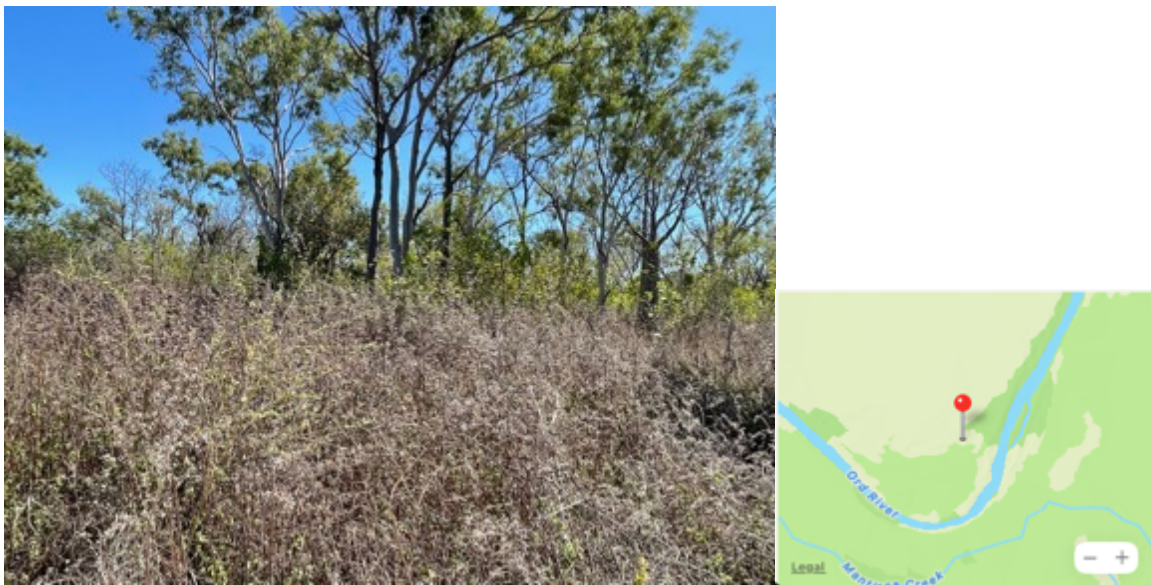
Y14 bore
 >90% weeds
 Occasional boab, neems, rain tree, Hiptis, Calotropis – thick
 No native understory. 90% weeds.
 Bore data taken – Wayne. Data downloaded.

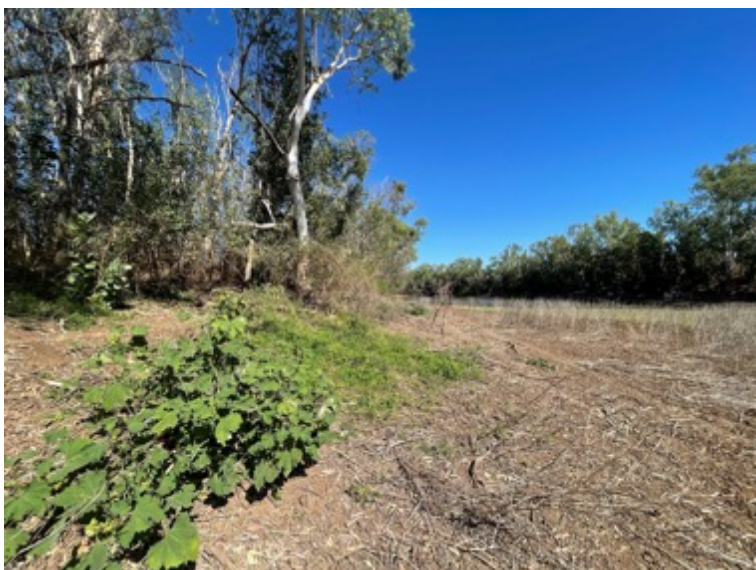
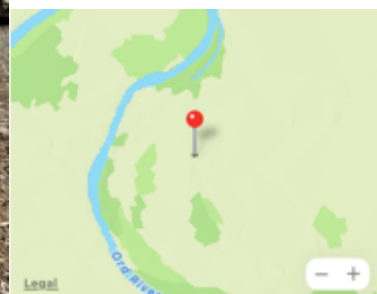
Cattle present (± 15 head)

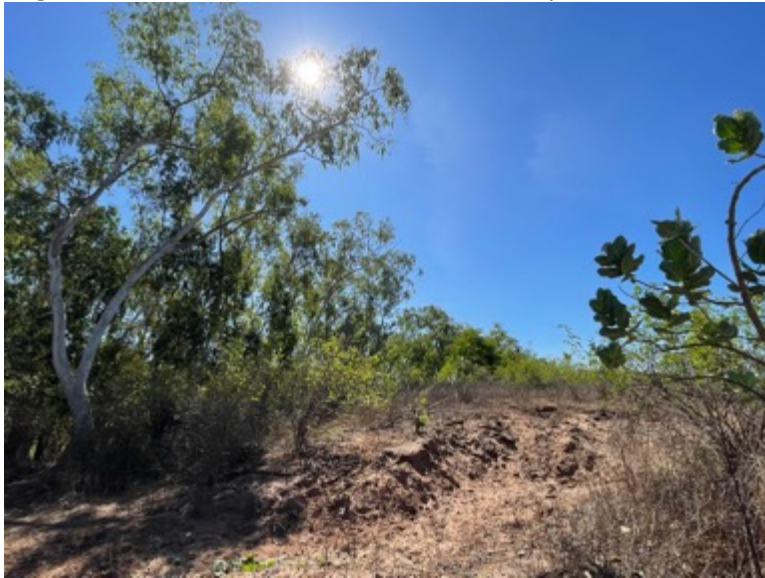
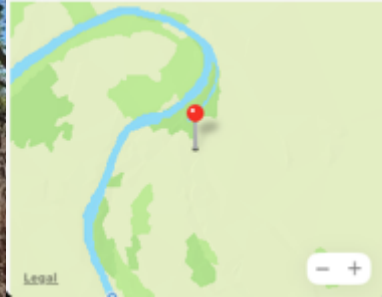
Noogoora Burr near remnant creek adjacent to Ord.

Vege Site 10: >90% weeds where soil is not exposed

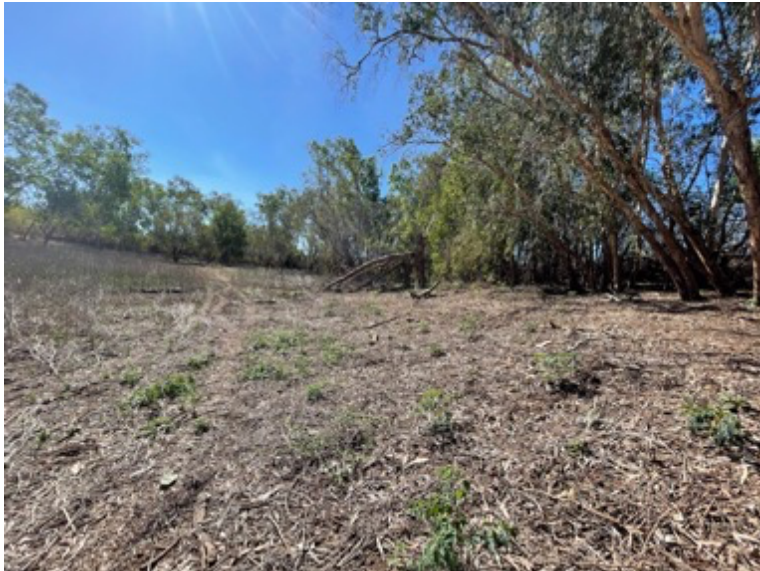
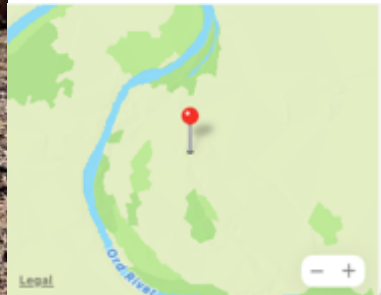
Vege Site 10 River side – Eucalypts in good condition; 50% weeds within 5-10m of site.

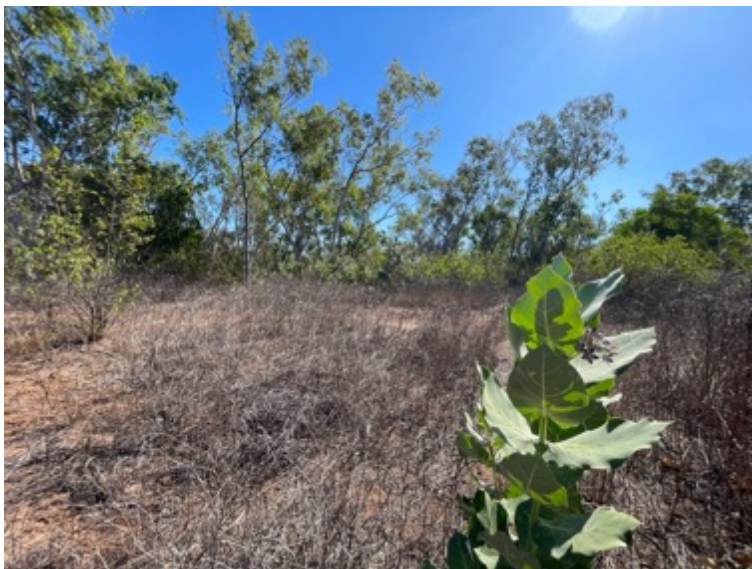
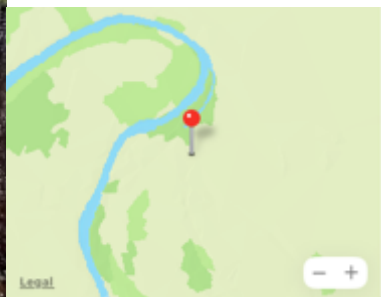
Cleared Carlton Plain area now 100% weeds. Calotropis in fruit. Weeds to 2m, very dense. Urgent weed control needed for fire risk mitigation.

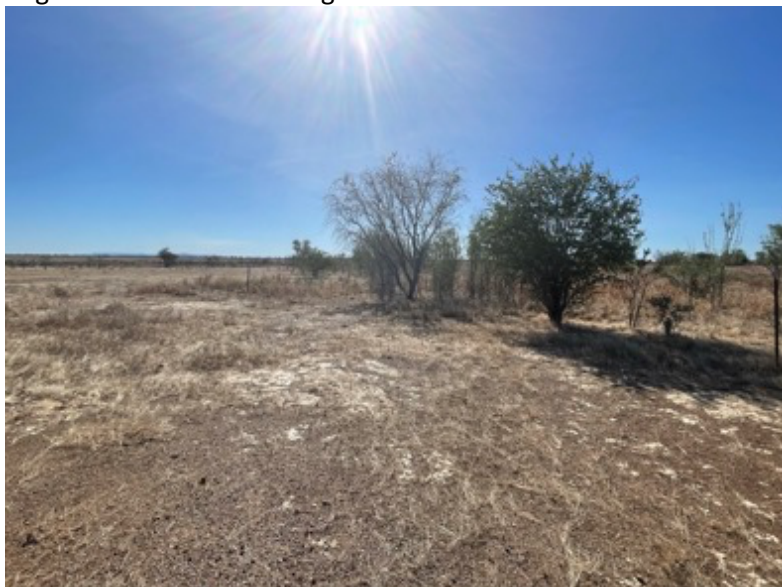
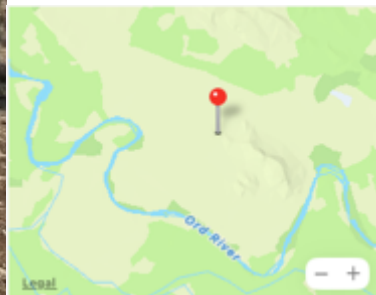
Carlton Wetland – condition good.

Vege site 6: 0-20% weeds: good condition.

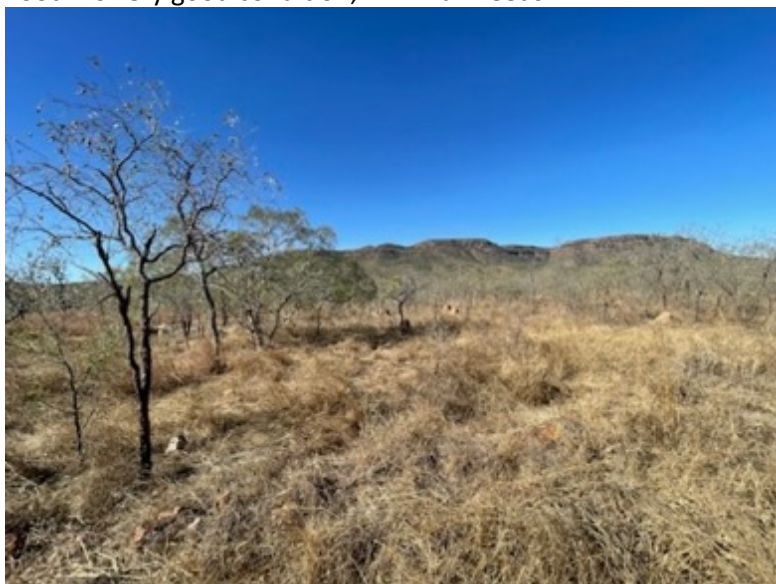
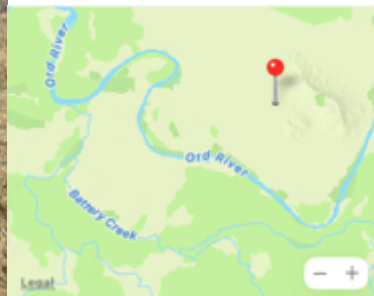
Foothills very good condition; minimal weeds

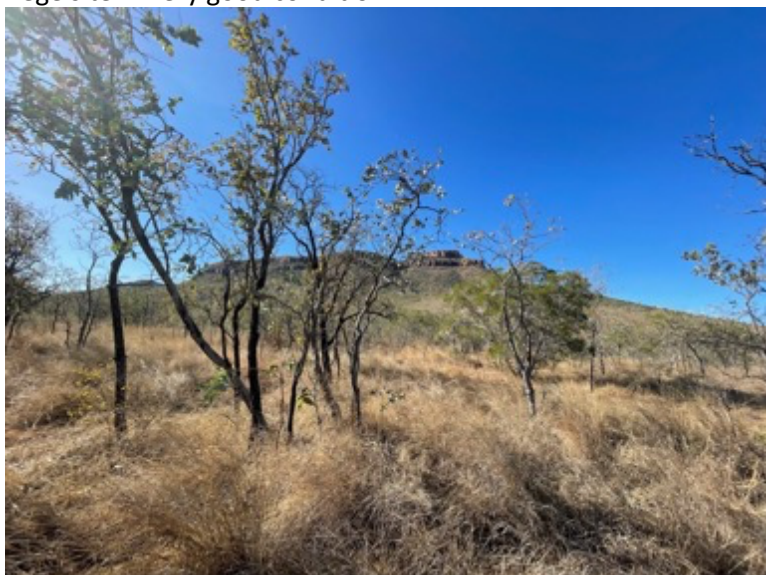
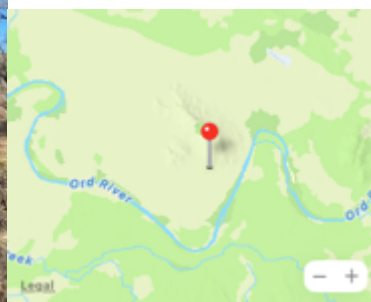
Vege site 7: very good condition

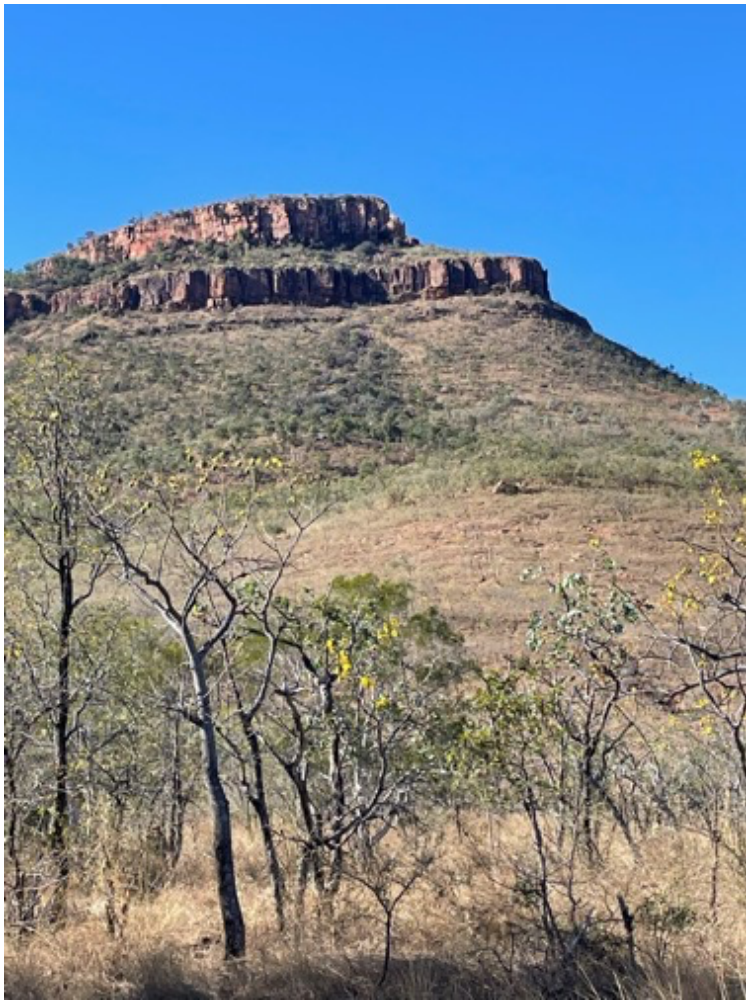
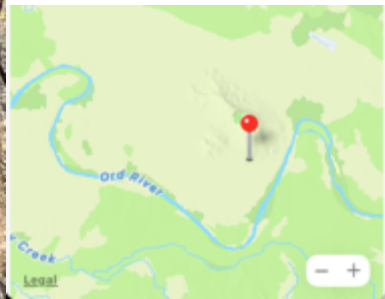
Vege site 8: very good condition, no weeds
