Carlton Plain Stage 1 – Irrigated Agriculture

COMPLIANCE ASSESSMENT REPORT

1 January 2022 – 31 December 2022

Statement 1081

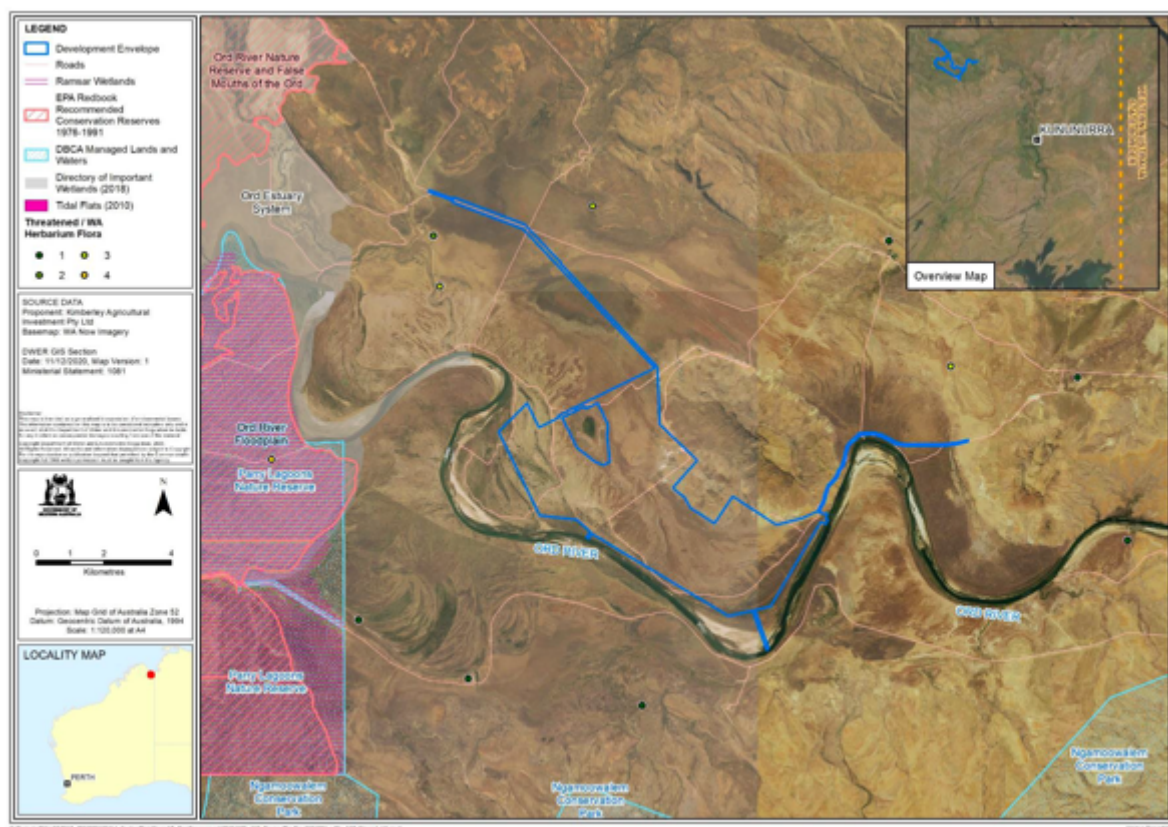
Figure 2. Carlton Plain Stage 1 Approved (revised) development envelope

Figures 1 and 2 illustrate the location and the revised development area. The variation reduced the permitted area of clearing by 110ha, to 2,945ha.

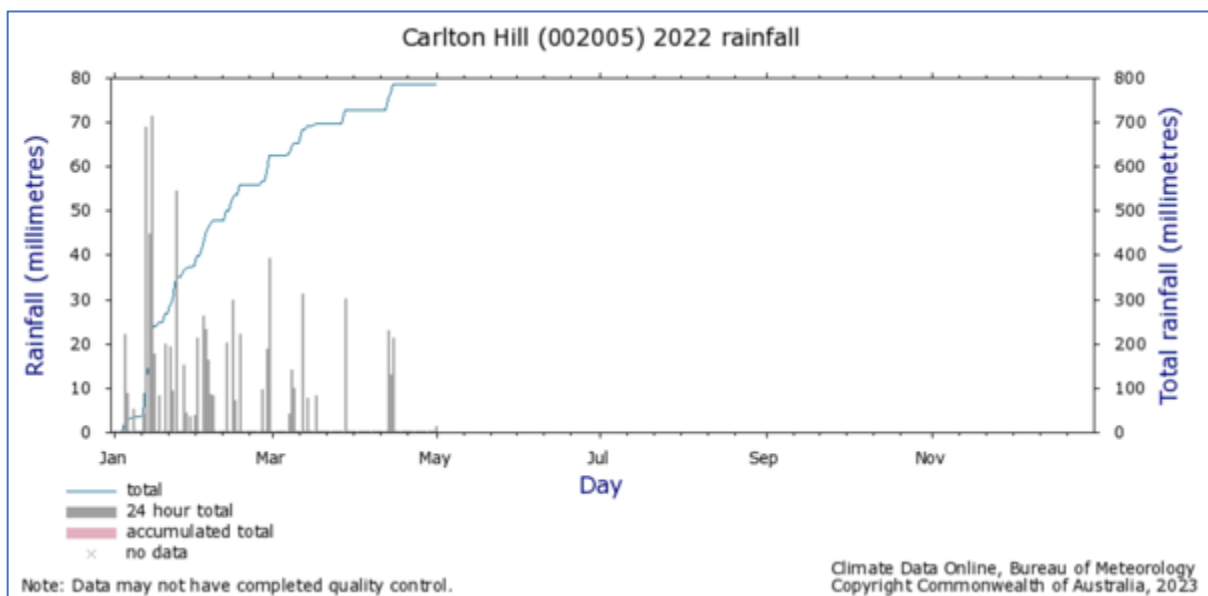
Figure 3. Carlton Hill Station Rainfall 2022

The reporting year (2022) saw a total of 786.3mm of rainfall recorded at the Carlton Hill Station weather monitoring station prior to Bureau of Meteorology (BoM) recording ceasing in May 2022. Nearby BoM site Wyndham Aero recorded 851mm in 2022, slightly above its median site rainfall of 801.1mm and mean of 835.7mm (BoM data, accessed 9/5/2023).

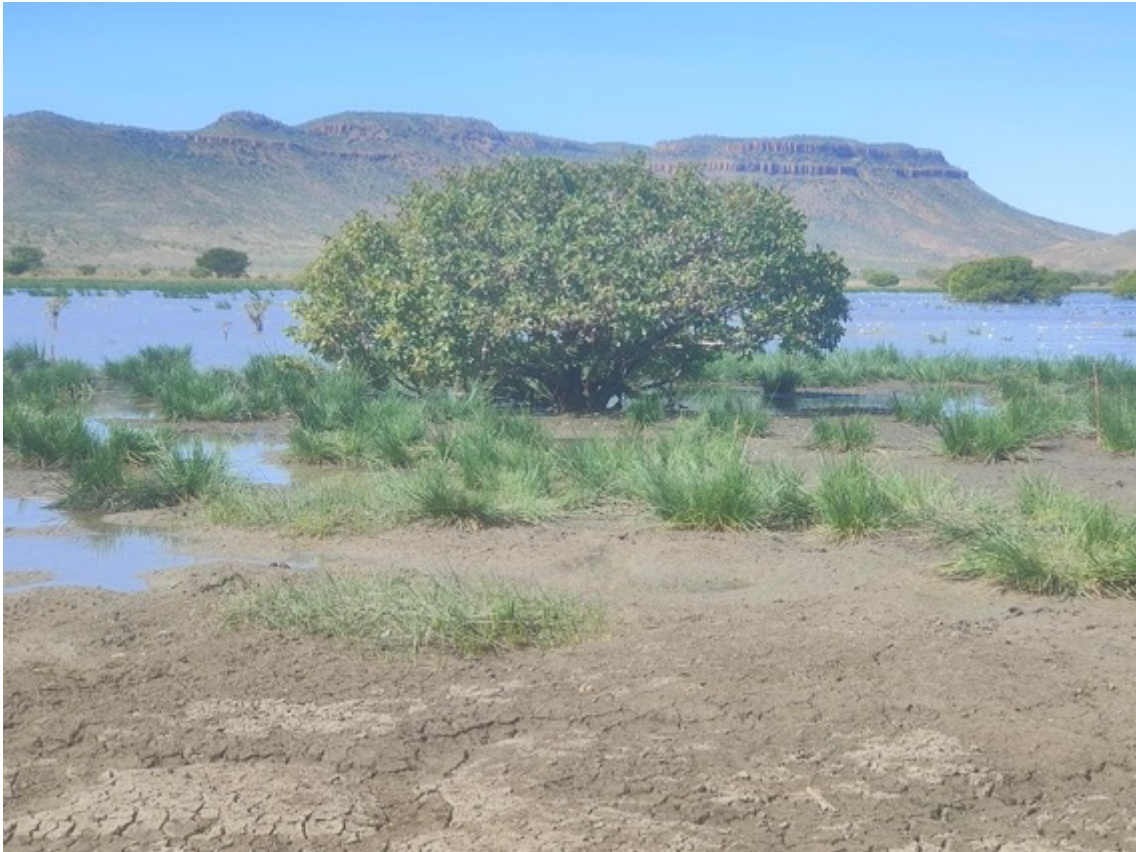
Plate 1. Carlton Wetland - 15 June 2022

The Carlton wetland ‘plumbing’ continues to operate effectively and recharges the wetland with hillside drainage from House roof Hill, per the project design. Consistent with the photographic evidence provided in the previous report (2021) the wetland was recharged successfully and remained functional for bird habitat. The removal of constant grazing has been a significant factor in the improvement of the wetland condition in recent years.

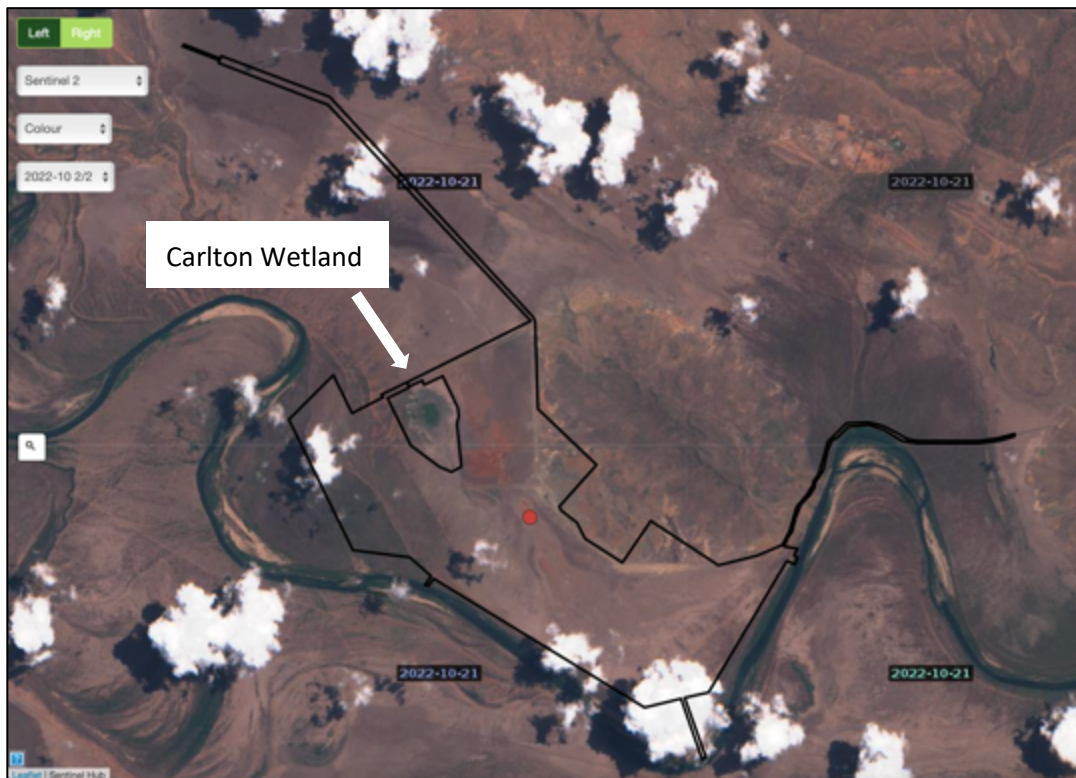
Figure 4. October 2022 Satellite Imagery indicating Carlton Wetland retaining water at end of dry season

No clearing outside of the approved development area has occurred. This can be confirmed through inspection of the aerial imagery in Figures 4 and 5, and in the December 2022 vegetation index imagery provided in Figure 6. Figure 6, when compared to the December 2021 image presented in Figure 7, also illustrates seasonal differences in vegetation coverage. Approximately 300mm of rain fell between October and December 2022, compared to approximately 200mm in the corresponding 2021 period.

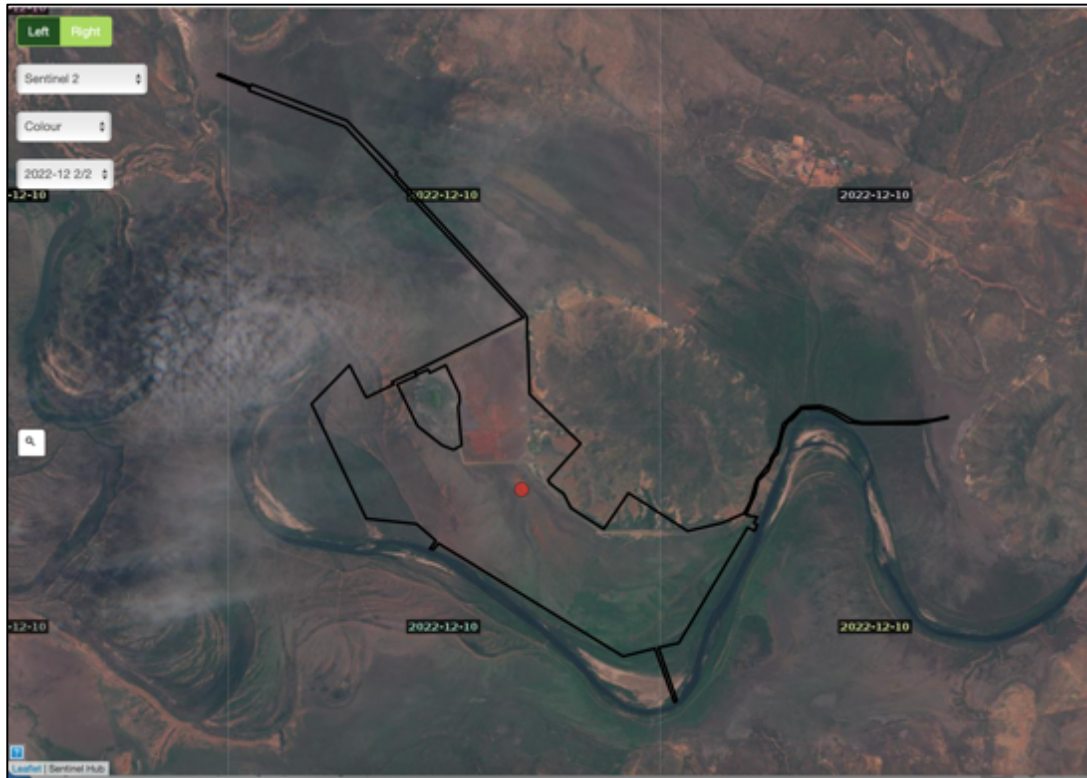
Figure 5. Carlton Plain Stage 1 at end of reporting period (10 December 2022)

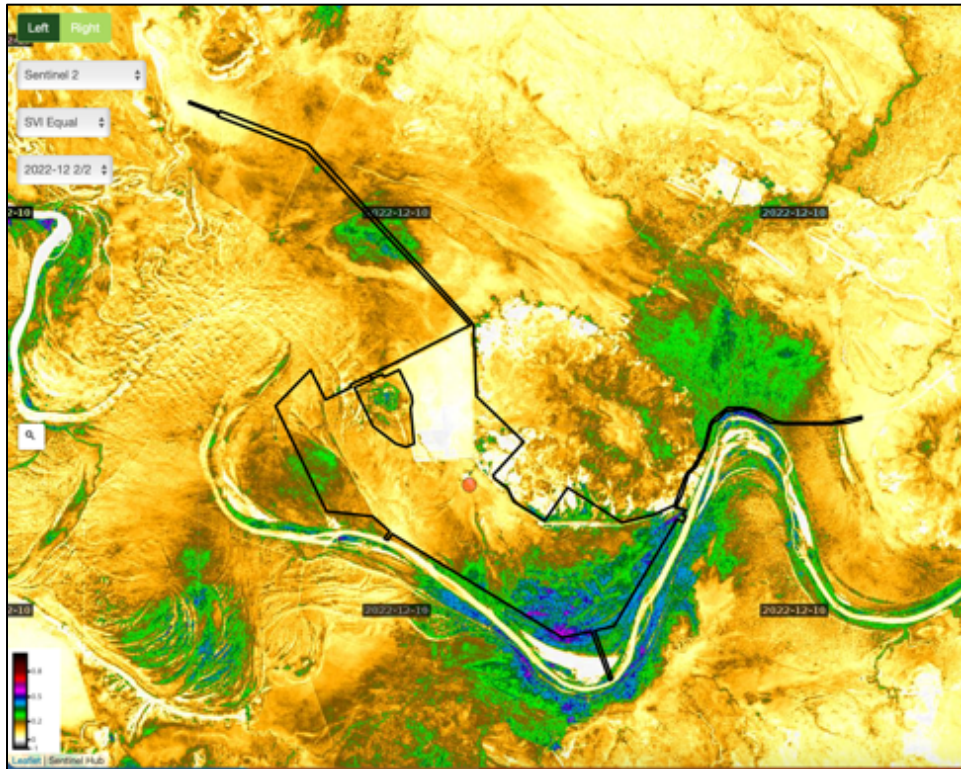
Figure 6. Carlton Plain Satamap Vegetation Index 10 December 2022

Figure 6 illustrates vegetation density across the development area, with equal bias to low and high biomass vegetation. This allows for distinction in pasture density.
